Expanded Site Inspection
Final Report

Pullman Factory
Chicago, Illinois
ILD 981 959 208

November 29, 1994

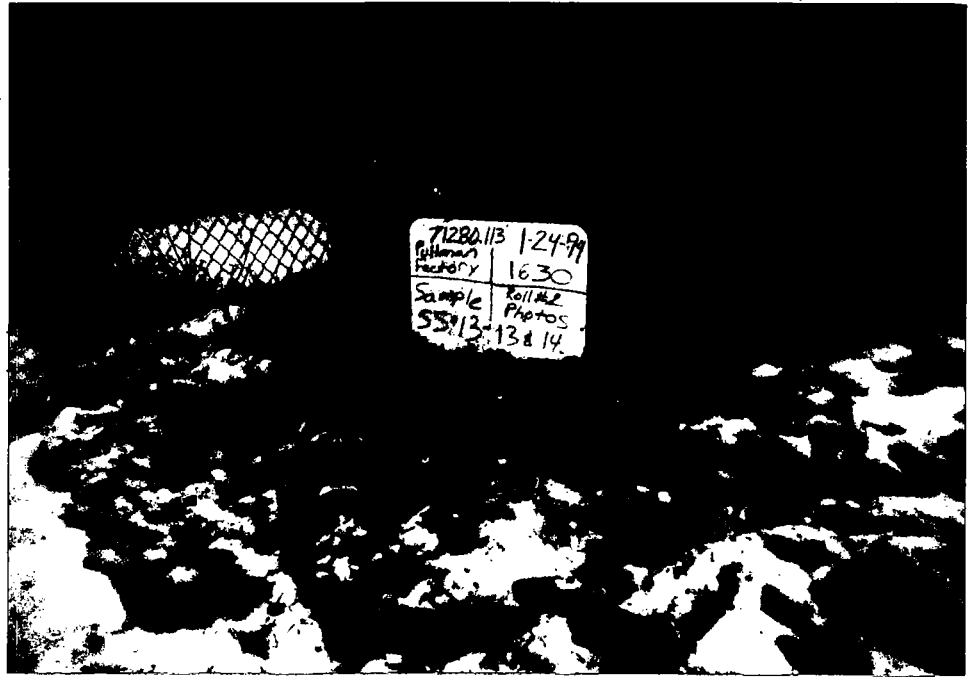
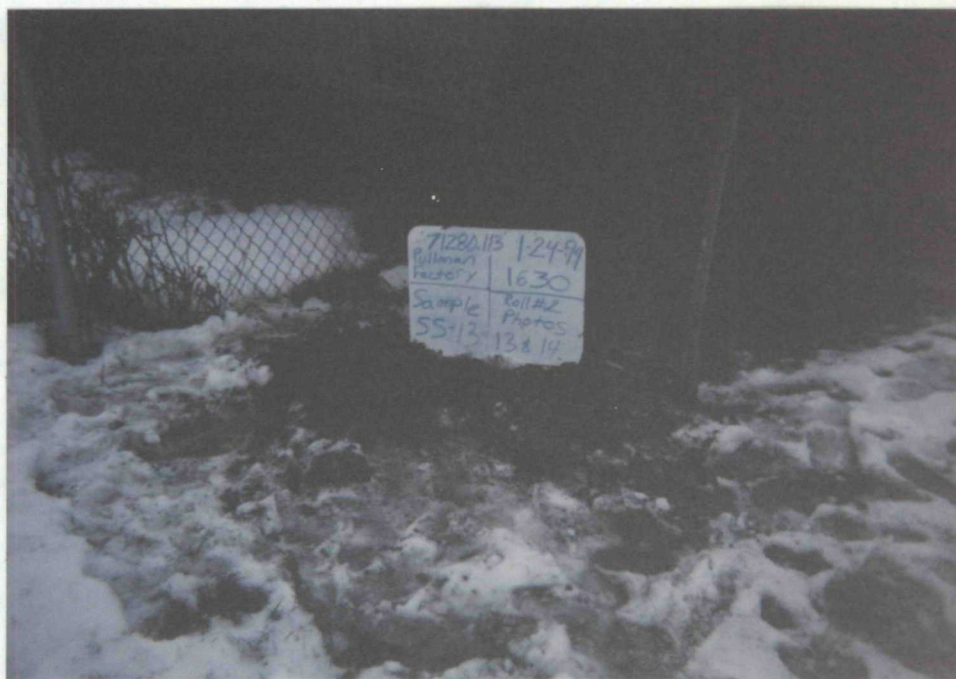
Description: Closeup of sample location
SS13, on front lawn of residence along
Forrestville Ave., in the southeastern
section of the site.

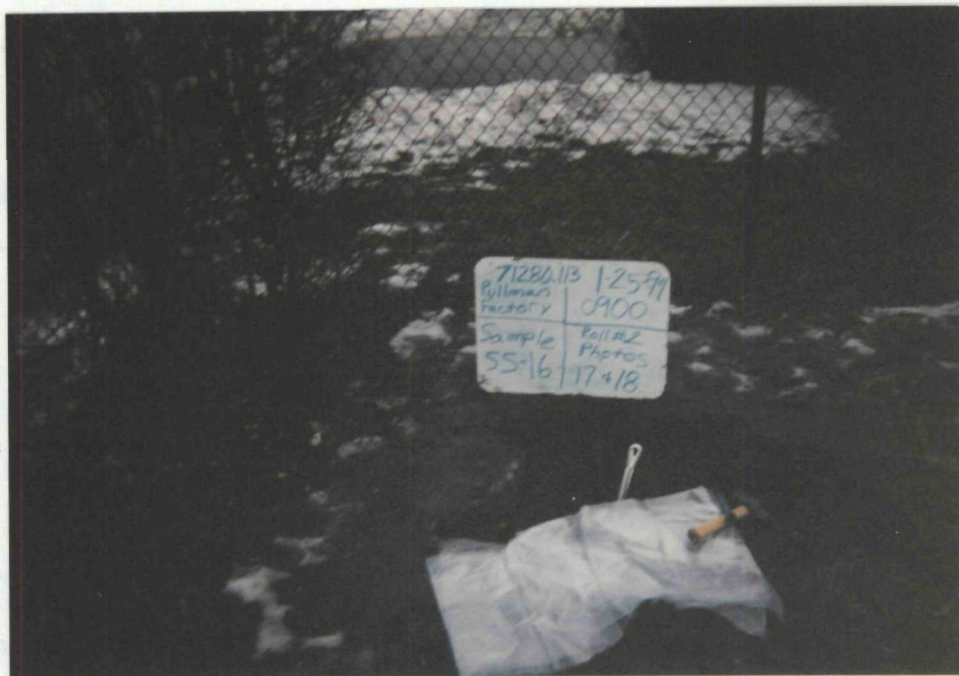
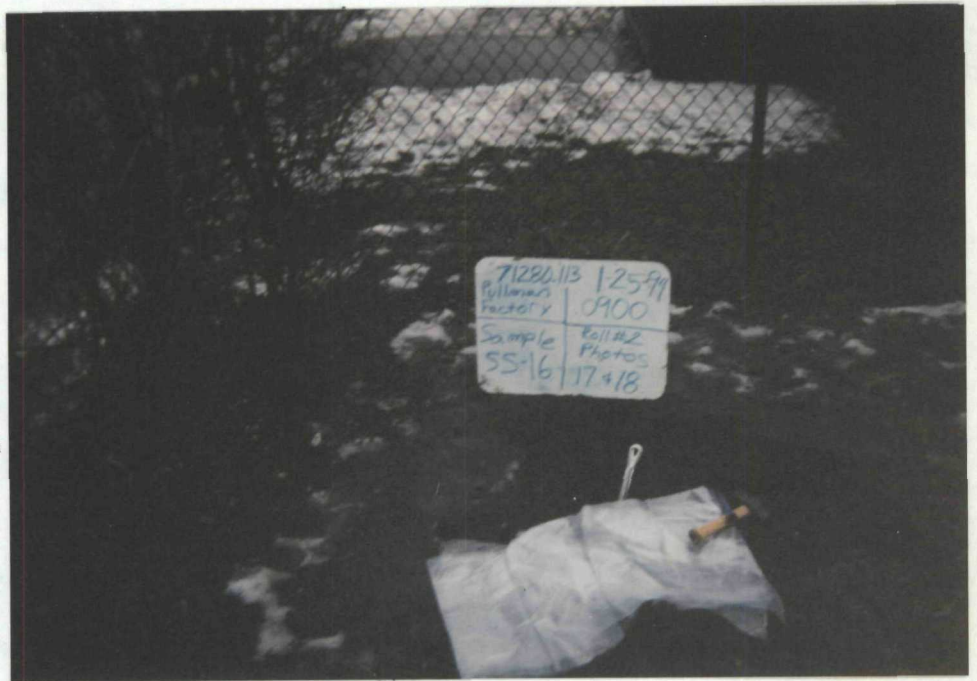
Description: Closeup of sample location
SS16, on side lawn of residence along
134th Street, just outside the southern
site boundary.

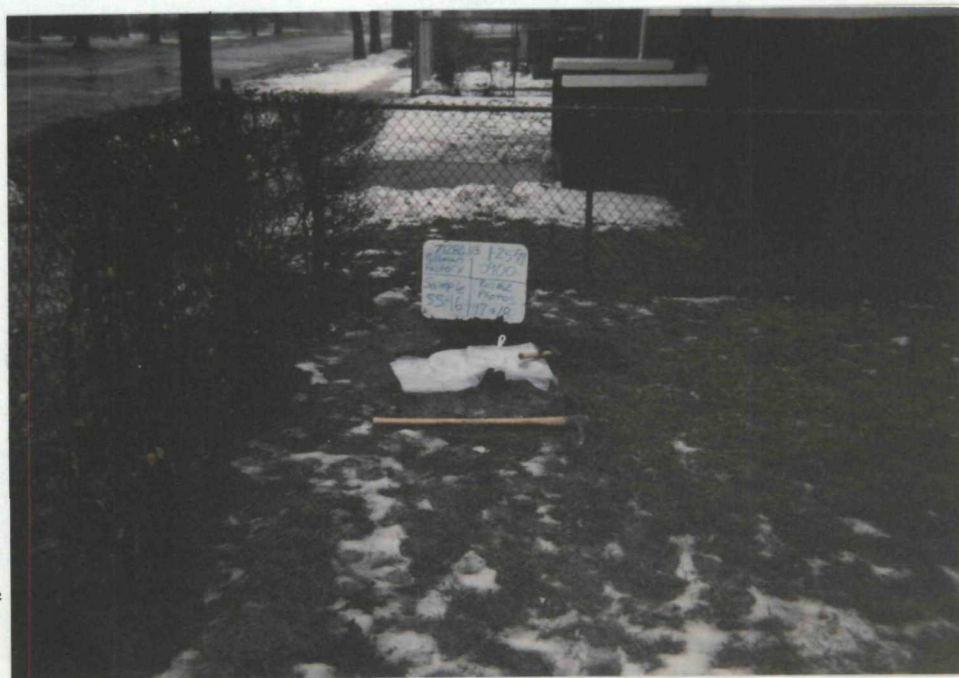
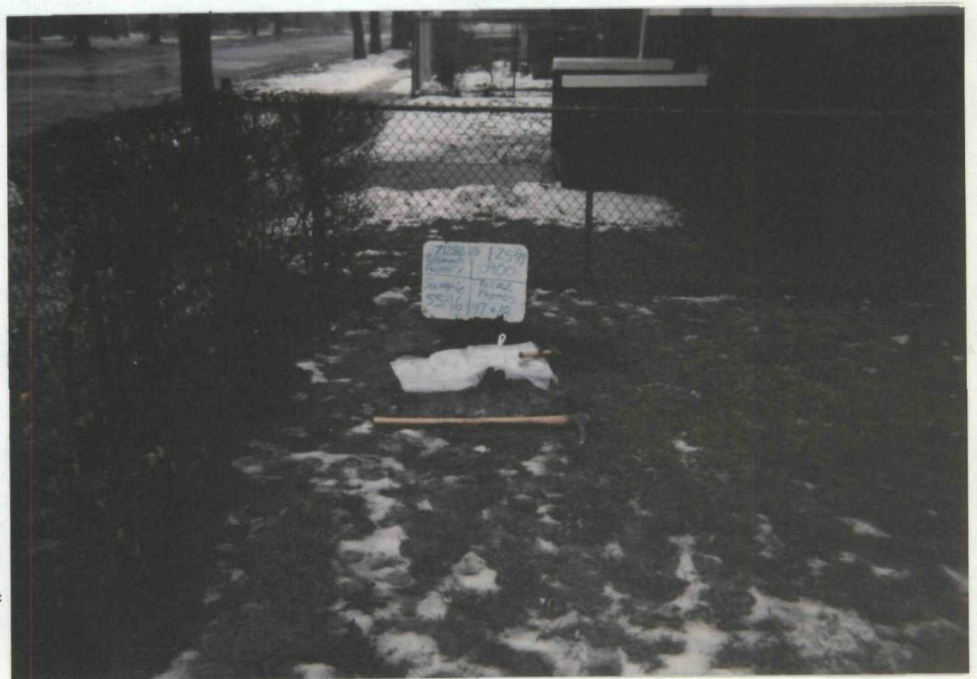
Description: Perspective view of sample
location SS16, on side lawn of residence
along 134th Street, just outside the
southern site boundary.

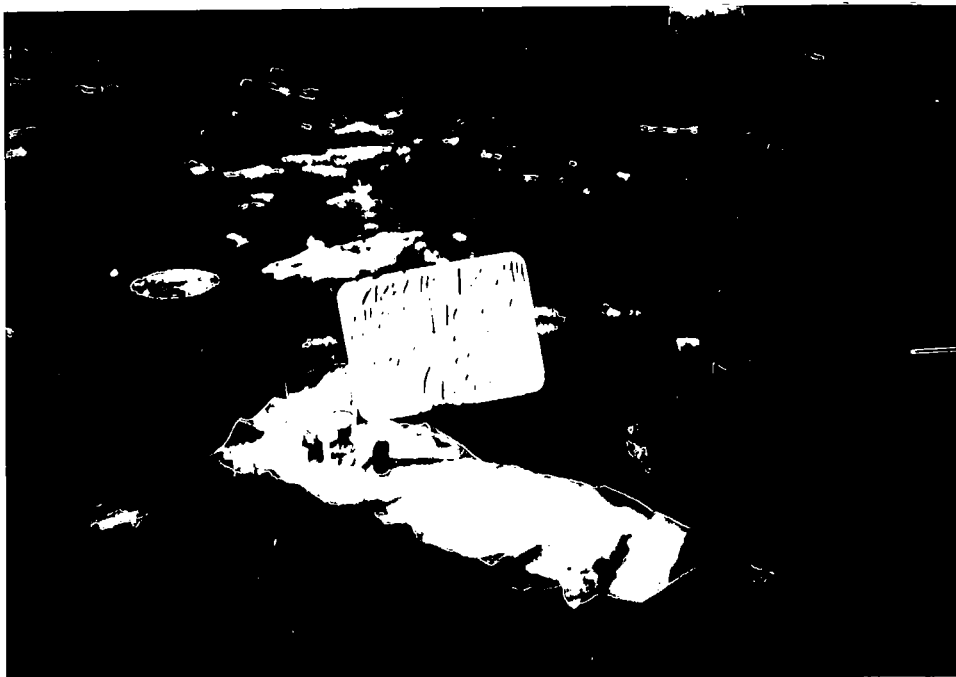
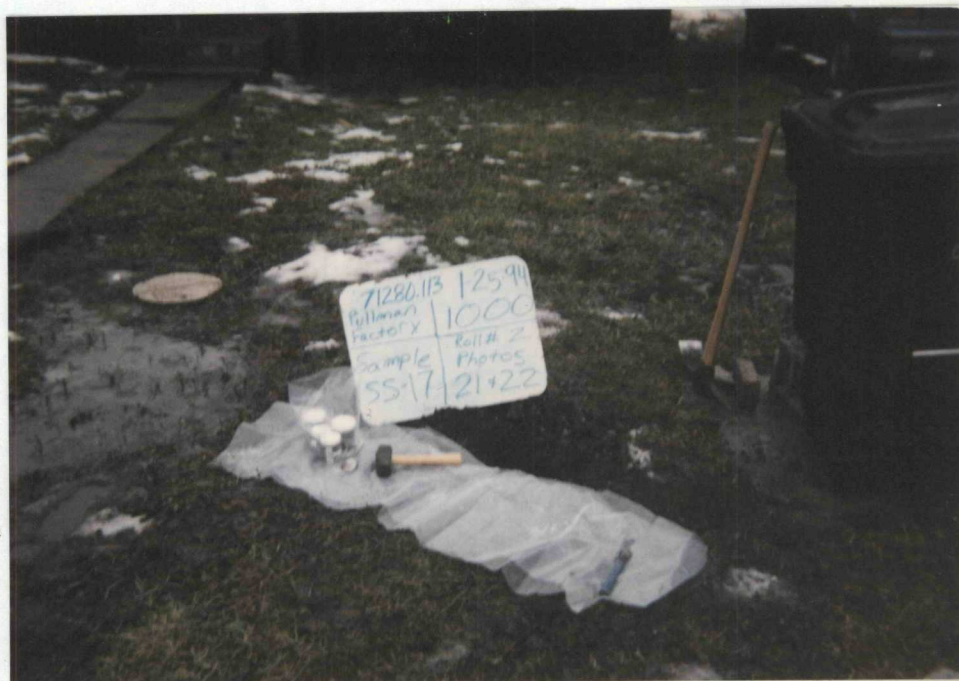
Description: Closeup of sample location SS17, on front lawn of residence along 134th Place, just outside the southeast corner of the site. Photo numbers shown on placard are incorrect.

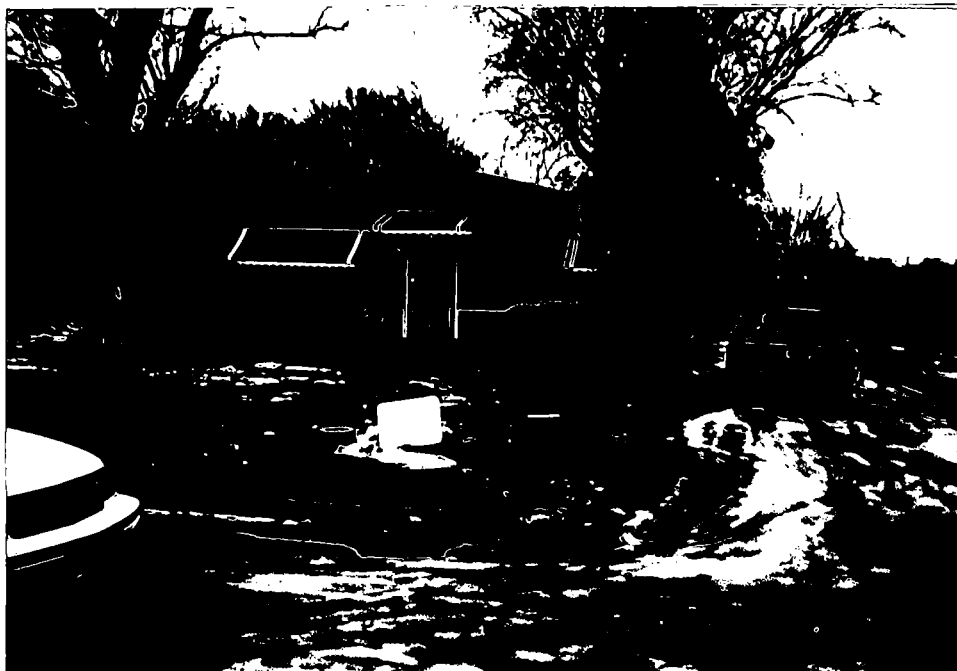
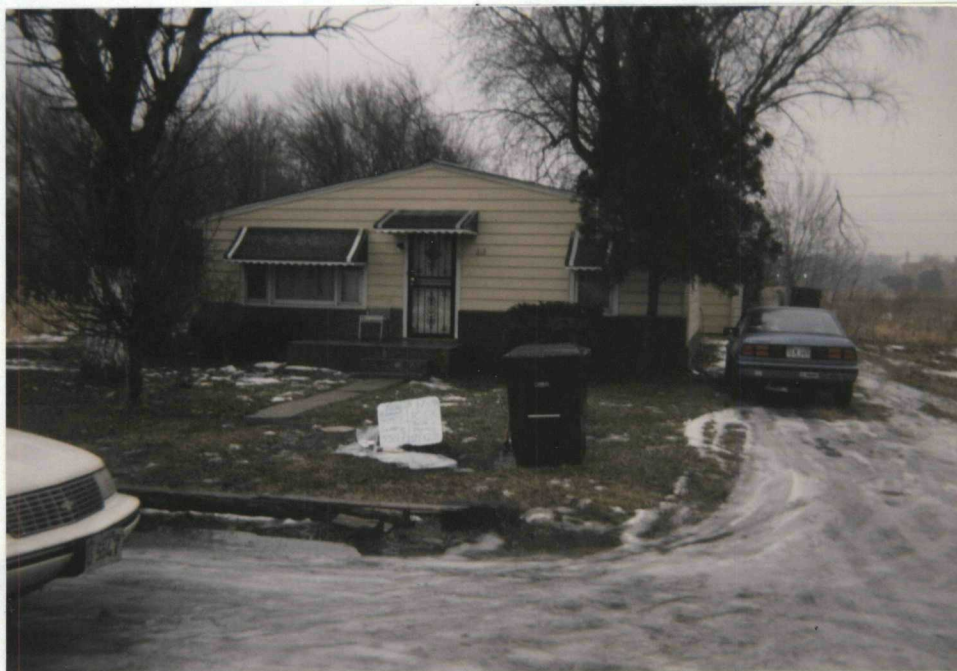
Description: Perspective view of sample location SS17, on front lawn of residence along 134th Place, just outside the southeast corner of the site. Residence in background.

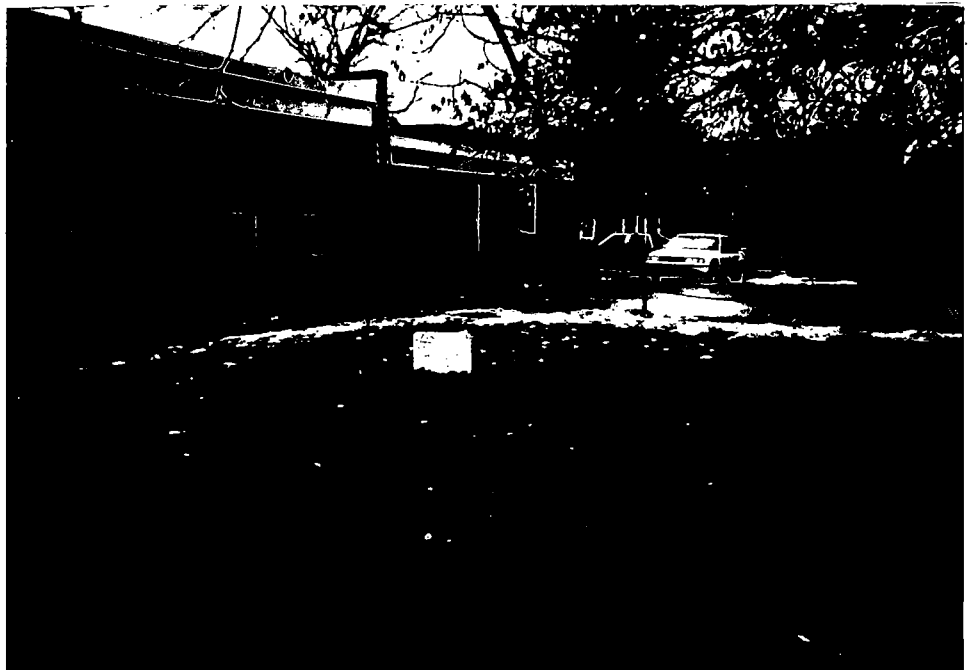
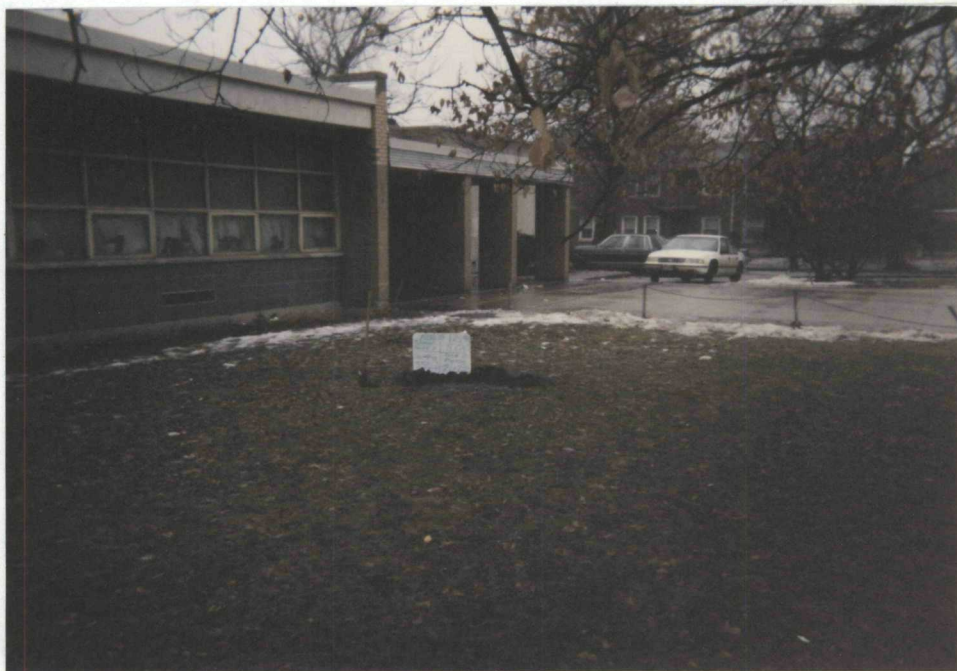
Description: Perspective view of sample
location SS22, on front lawn of the Ira
F. Aldridge Elementary School, just
east of the site. School is in left
portion of photo.

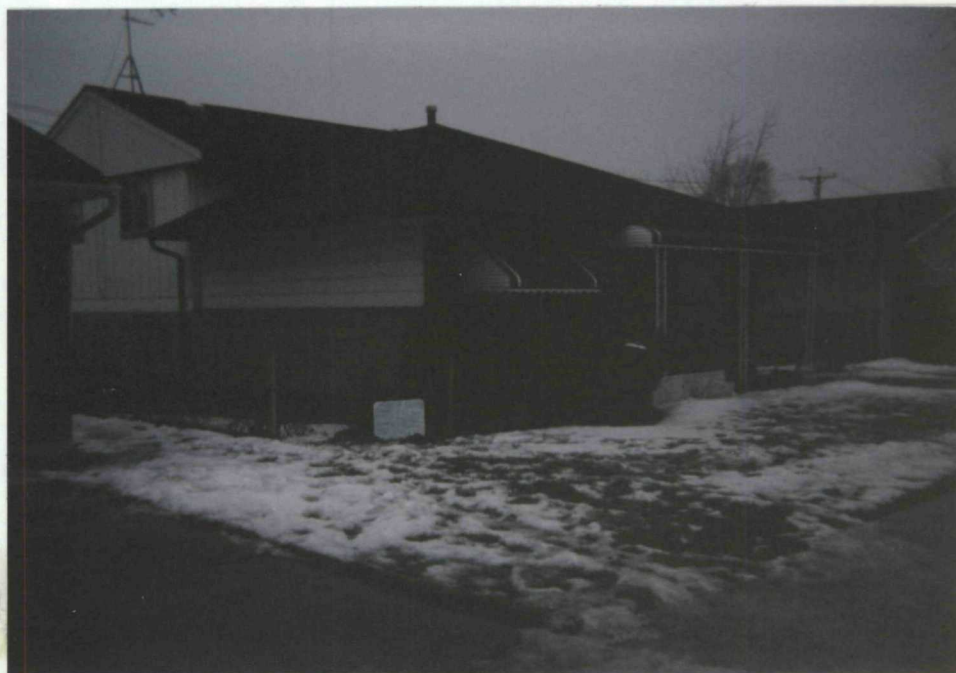
Description: Perspective view of sample
location SS13, on front lawn of residence
along Forrestville Ave. Residence
is in the background.

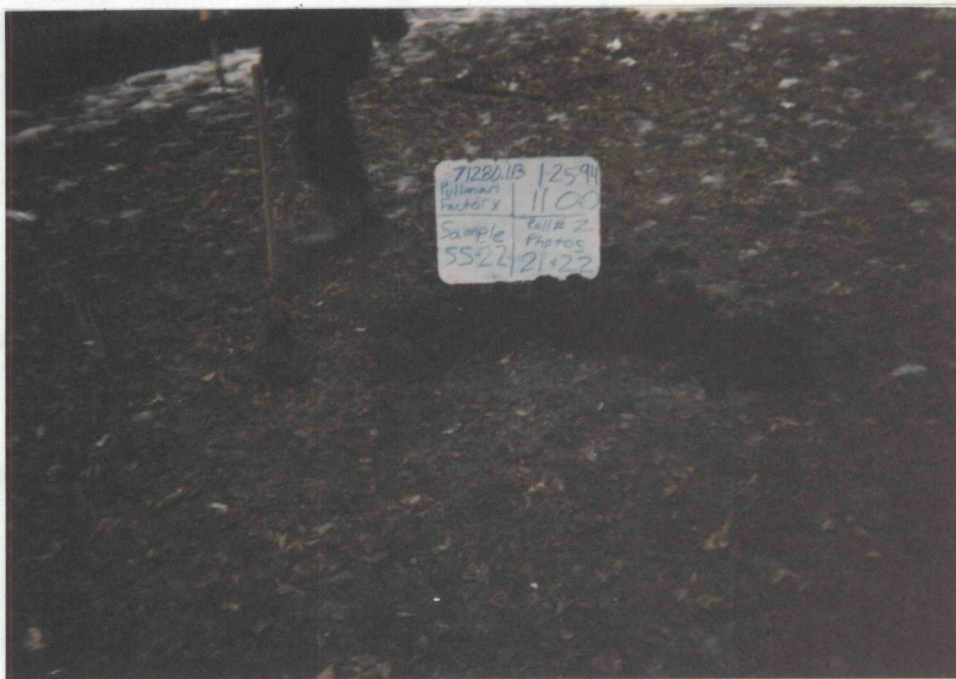
Description: Closeup of sample location
SS22, on front lawn of the Ira F. Aldridge
Elementary School, just east of the site.
